The detailed characterization of land threatened by water erosion with soil type chernozem on loess at Dambořice

Abstract: In the Czech Republic chernozems are among the most fertile soils and are intensively farmed. It turns out that when using intensification measures, enlarging fields, using substandard farming practices and cultivating wide-row crops, water erosion becomes a major problem. The result is degradation of physical properties, compaction and depletion of the most fertile part of the soil - topsoil.

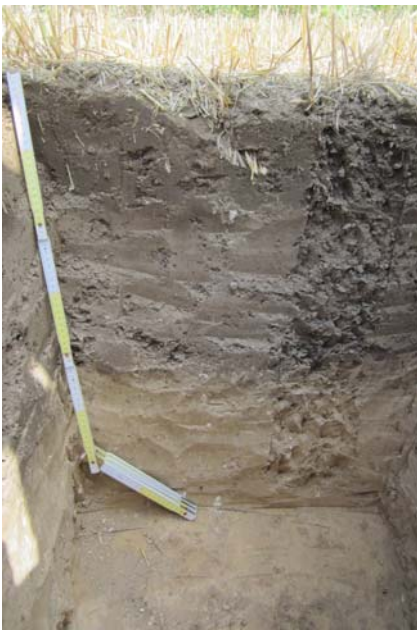
Fig. 1 Top of the hill (A)

According to the structure we can specify a segment of the original topsoil horizon (0-0.3 m), which is

currently only subject to disking to a depth of 0-0.2 m. In the disked horizon, the structure is crumbled and weakly developed. In the former topsoil horizon, now at a depth of 0.2-0.3 m, the structure is polyhedral. We can find a medium recovery and weak rooting. At a depth of 0.3-0.4 m is a horizon Ac, which differs from the above-lying by a strongly polyhedral structure and a weaker rooting. The transitional horizon is at a depth of 0.4-0.47 m with a polyhedral structure and from 0.47 m there is loess with ocher color. It is dry, hard, without a clear structure with the appearance of pseudomycelium.

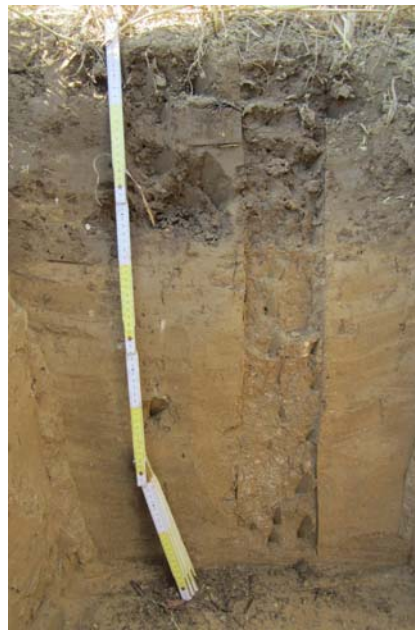
Fig. 2 Hillside (B)

In the middle of the slope it was already evident according to the color that the surfaces were and currently still are experiencing water erosion, where the original Ac horizon is taken away and its remnants are gradually mixed with loess. Also here the Ap horizon is divided into two layers, while up to 0.13 m the structure is moderately developed, crumbled and medium rooted and from 0.13 to 0.27 m the structure is then developed, polyhedral with weak rooting. Throughout the horizon, there are loess nodules. After a sharp transition caused by plowing there is the mother substrate in our case loess Ck. Abundant occurrence of loess nodules decreases with depth.

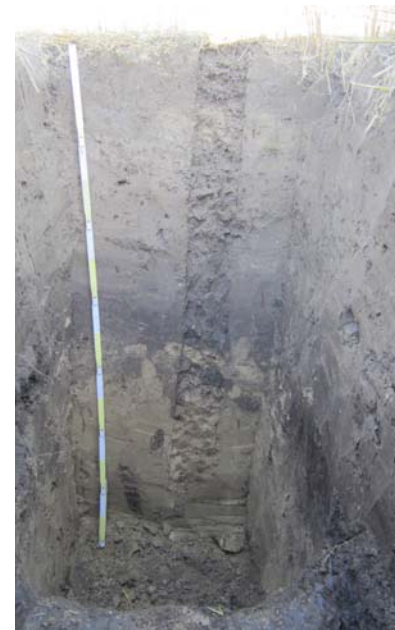
Fig. 3 Foot (C)

In locations under the hillside alluvial material gets accumulated, that buries the original humus horizon. Ap horizon extends to a depth of 0.34 m. To 0.13 m, the structure is crumbled and lumpy, moderately or well developed. In 0.13-0.34 m the structure is lumpy to polyhedral, moderately developed. Infrequent occurrence of loess nodules. Biological activity and rooting – moderate to 13 cm and weak from 0.13 to 0.34 m. Below that is the horizon AZx - formed by accumulative deposition of materials of humic horizons of colluvial soils that extends to a depth of 0.73 m. The horizon has a weakly to moderately developed checked structure with weak rooting and biological activity. Transition to loess gradual in 0.73 m. In the depth of 0.73-0.93 m we can find original Ac horizon with crumbled structure and medium biological activity. The transition to the loess is slow.
